CIVIL AERONAUTICS BOARD

AIRCRAFT ACCIDENT REPORT

PAN AMERICAN WORLD AIRWAYS, INC., BOEING 377, N 90944,
 IN THE PACIFIC OCEAN, BETWEEN HONOLULU AND SAN FRANCISCO,
 NOVEMBER 9, 1957

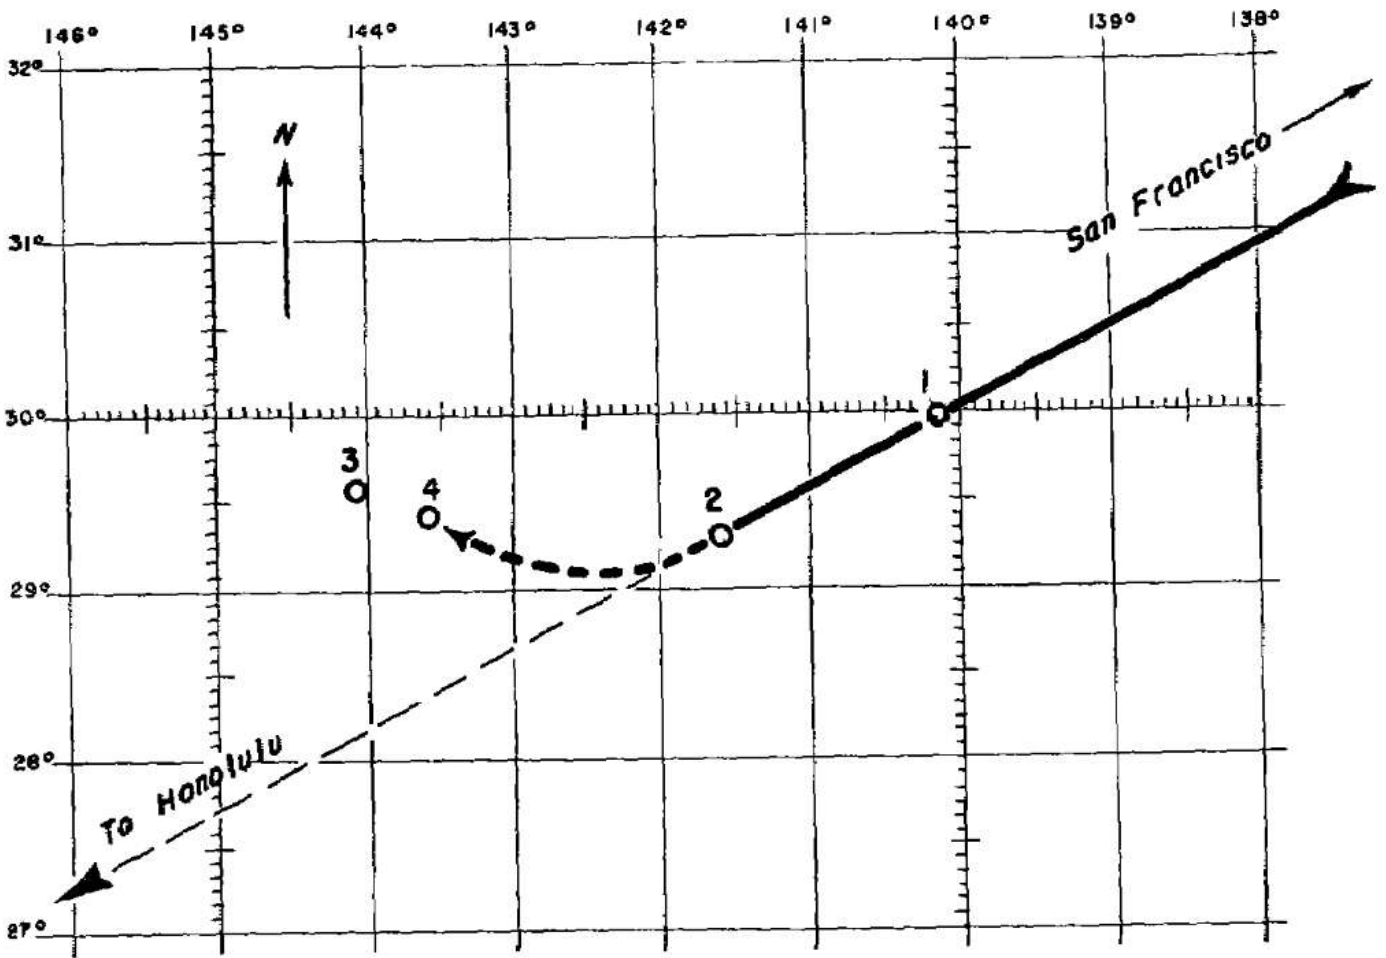
- 1 Weather Vessel Approximately midway between San Francisco and Honolulu
(29° 59' N - 140° 8' W)
 - 2 Last reported position of 944
(29° 20' N - 141° 35' W)
 - 3 Wreckage and bodies
(29° 36' N - 144° 3' W)
 - 4 Probable impact
(29° 26' N - 143° 34' W)
- SCALE
0 50 100
NAUTICAL MILES

Known path
 Probable path
 Planned path

All required position reports were made and Clipper 944 reported to Ocean Station vessel "November" at 0030; its position was fixed by radar as 10 miles east of the vessel. The last position report, at 0104, was routine with no indication of anything unusual.
